Repair of a damaged point of attachment

INDUSTRY COMMUNIQUE

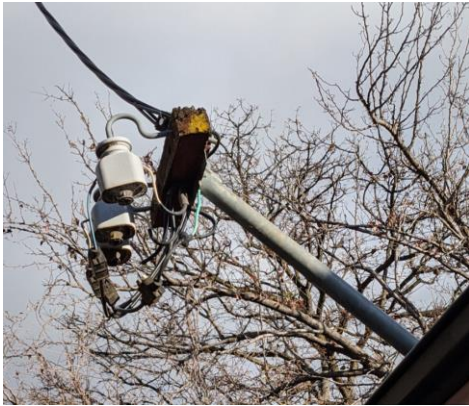
Image 1: Reported as weathered timber batten

There is no safety issue present, the fuses are secured, neutral and MEN termination to standard and service cable secured. If concerned about the fuse holders being secure enough to pull the fuse, a ladder can be used to access the POA with a short fuse puller to undertake isolation.

All suitable safety precautions should be followed as documented by your organisation.

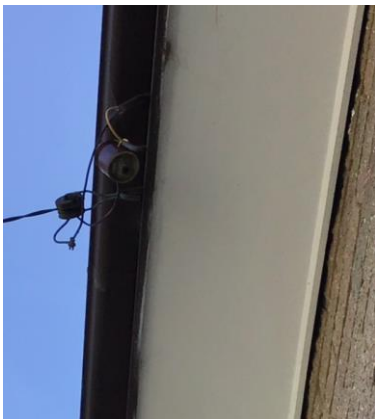
Image 2: Reported as fuse on an angle

A fuse on an angle is not to be reported to Evoenergy. The angle of the fuse is dependent on the customer's asset installation. A ladder can be used to access the POA with a short fuse puller to undertake isolation. All suitable safety precautions should be followed as documented by your organisation.

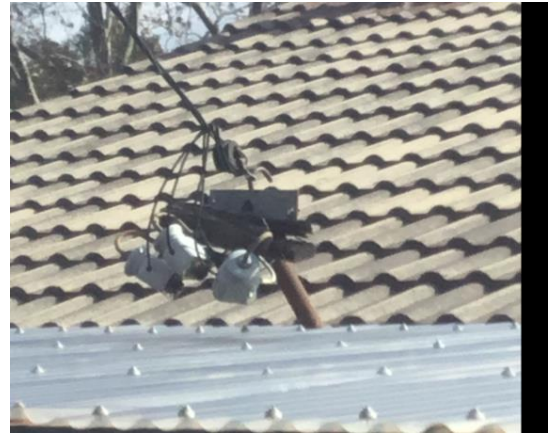
Image 4: Reported as damage timber batten

In this situation the fuse holders are completely unsecured and there is possible tension on the terminations at the consumer side of the fuse holders. Evoenergy shall attend site to make safe.

Calls should be made to Evoenergy's 24-hour emergencies and faults on 13 10 93.
